Condensate Induced Water Hammer in a Steam Distribution System Results in Fatality

KH-SA-3026-FP

**CONDENSATE INDUCED WATER HAMMER IN A STEAM DISTRIBUTION
SYSTEM RESULTS IN A FATALITY**

ICF KAISER HANFORD COMPANY
RICHLAND, WASHINGTON

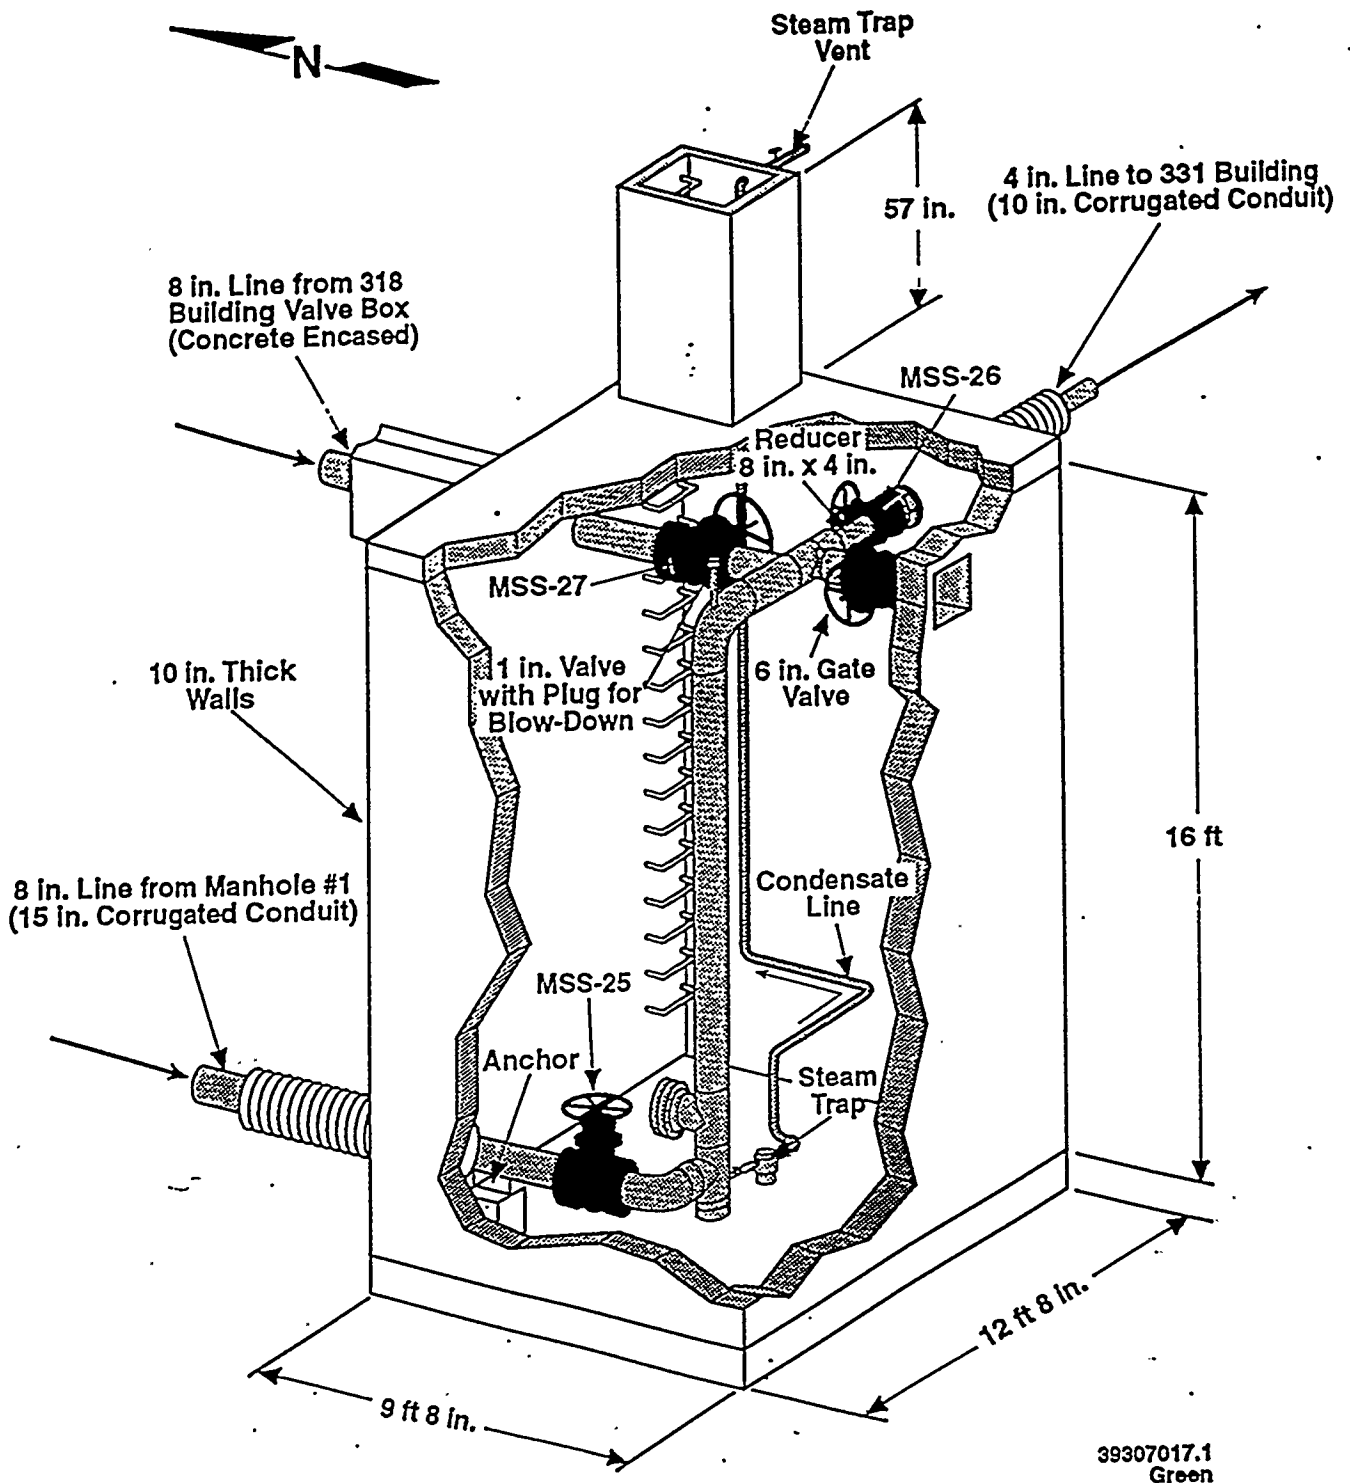
FIGURE 1

On June 7, 1993, at about 7:00pm, a Westinghouse Hanford Company Journeyman Power Operator received critical steam burns and lung injuries while opening an 8-inch main steam line isolation valve, MSS-25, (see figure 1) in the steam valve (U-3) pit in the 300 Area of the Department of Energy Hanford Site. The U-3 pit is a part of a process steam supply system using steam at about 350 degrees fahrenheit and 120 psi.

Conditions in the steam system included a large quantity of condensate (approximately 1500 gallons) backed up in a 840-foot run of the main steamline between valve MSS-25, which is the lowest point in the system and the next isolation valve. The condensate was fairly cool since this portion of the piping system is underground and had been inactive for 8 months. Steam was on the downstream side of MSS-25 with a functioning steam trap in this section of the line. The upstream side of the valve was also pressurized to allow steam flow to the 331 building. The operator entered the pit, unlocked and opened the 8 inch isolation valve, MSS-25. Indicators are that he opened the valve over 50 percent in 1 to 2 minutes. Condensate rushed into the steam filled downstream piping, filling the vertical leg and when sufficient quantity had entered the next upper horizontal section a water hammer ensued. This initiated a severe thermal-hydraulic transient, resulting in a condensate induced water hammer with pressures up to about 2300 lbf/in² in the pit piping. The transient was terminated quickly by a rupture of a 6-inch cast iron, blind flanged isolation valve in the upper section of the pit. The rupture created an instantaneous release of high pressure water and steam into the pit.

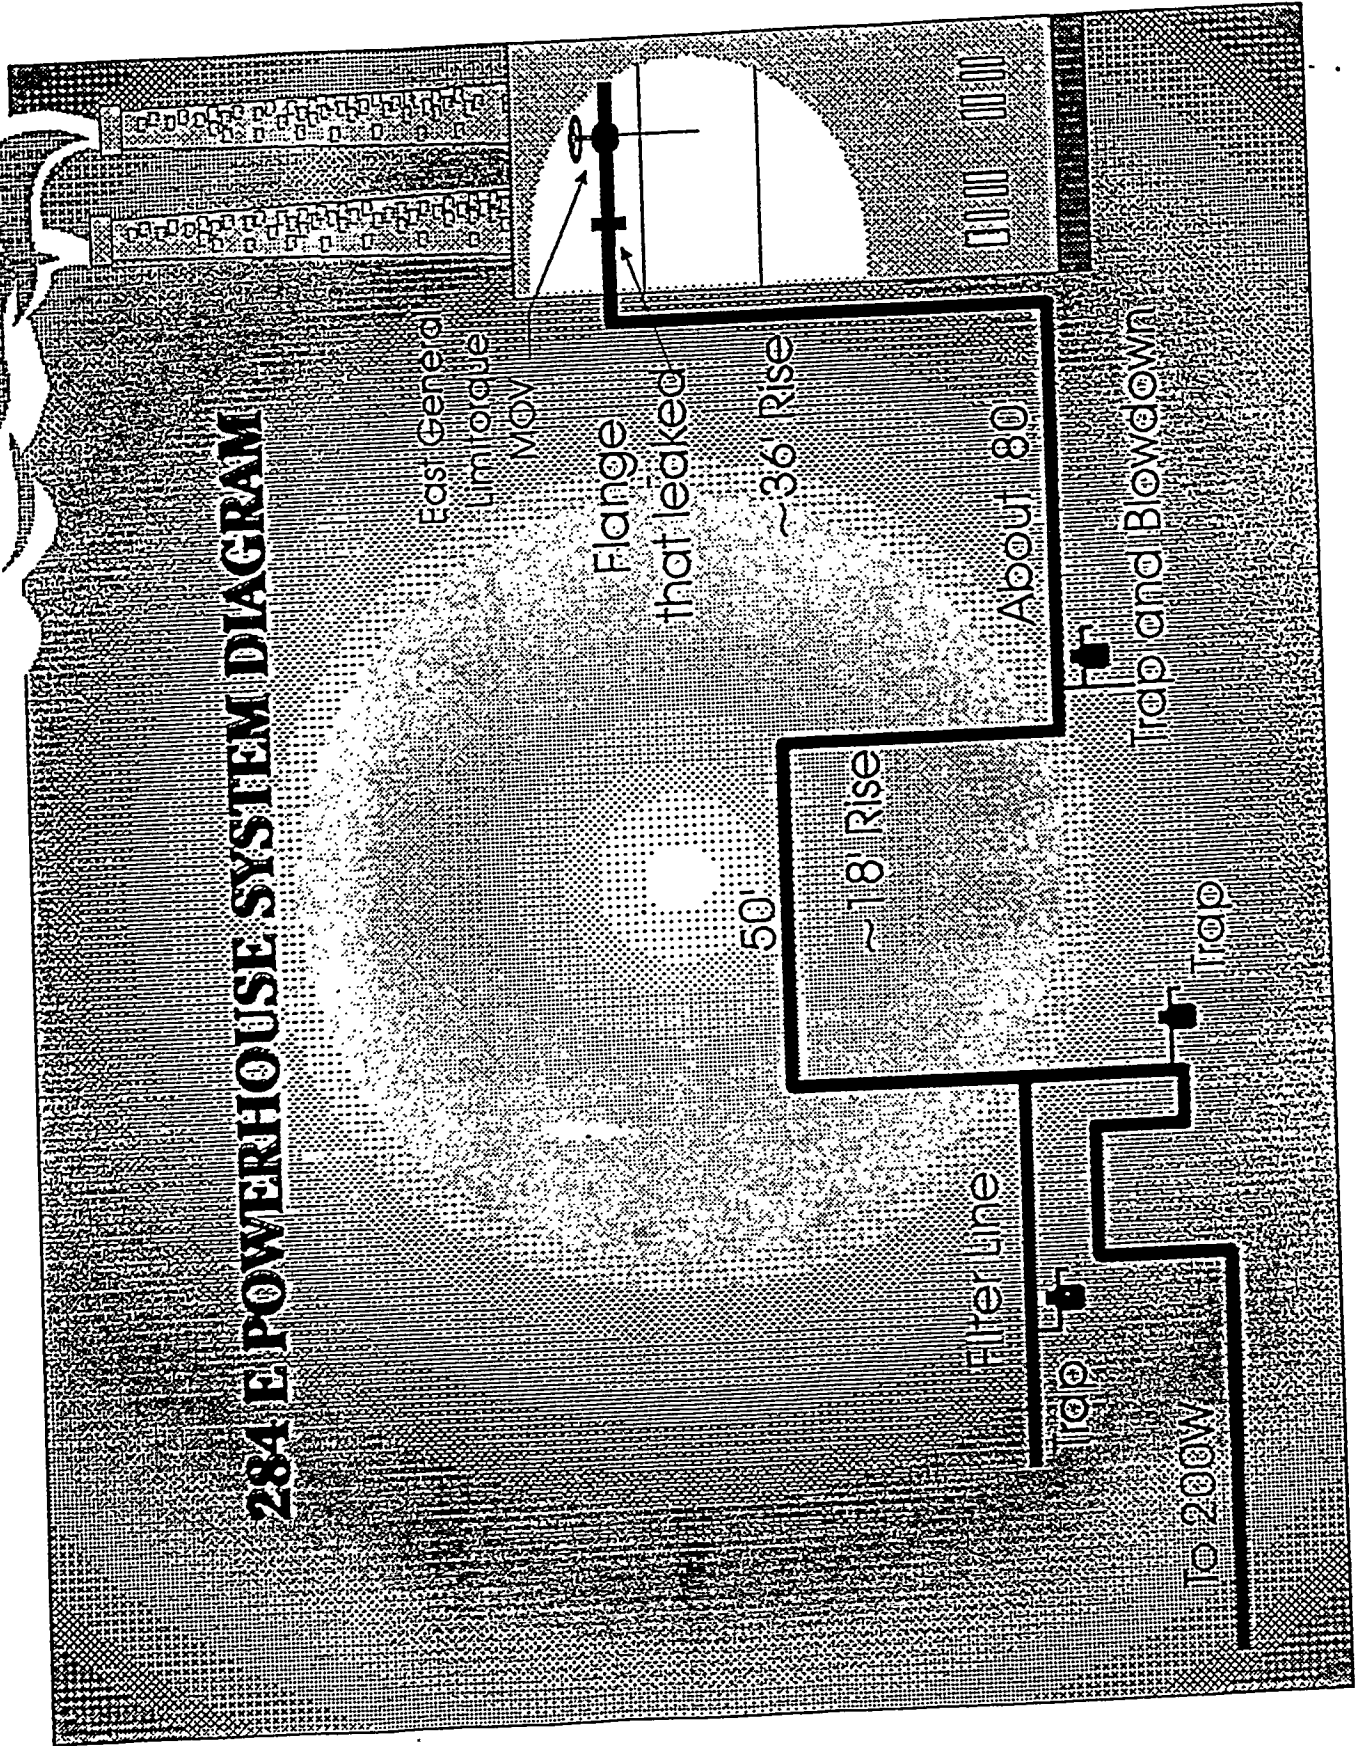
FIGURE 2

Significant accomplishments were made in implementing the action plan. However, on June, 16, 1994 (one year after the fatality), another condensate induced water hammer was experienced at Hanford. At a site, 20 miles North of the previous water hammer, during a steam restoration evolution at the 284E powerhouse a condensate induced water hammer occurred when the operators began to "crack open" the main 12" limitorque valve (see Figure 2), which would initiate steam flow and begin the heat up process. A horizontal section of piping from the road riser, up to the East general limitorque valve, filled with condensate, during a two week outage. Approximately 700 gallons of condensate collected in the pipe. No personnel were injured, but moderate damage was sustained by the piping supports and three elbows on the 12" steam line exceeding their yield stress. Also, a 12" flex gasket failed due to

stressing of the flange bolts, breaking system integrity, which caused water and steam to be discharged.

When the limitorque valve was cracked open, condensate, under steam pressure of 225 psig, flowed into the powerhouse piping system. When the level in the lower horizontal section decreased to create a void between the condensate surface and the top of the pipe steam flowed into this space and set up the condition for the condensate induced water hammer, which lasted between 5-6 minutes.

Investigation later revealed that the condensate build up was due to a 15 psi trap being installed in the 225 psi system. The trap could not function to discharge condensate in this condition.
